Lake Shastina Community Services District Field Report

Underwater Cleaning & Inspection
300,000 Gallon
Tank 2
Potable Water Storage Tank

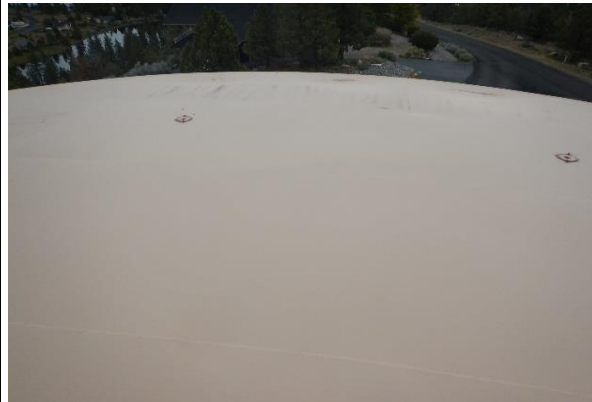
Cathodic Protection Plates Sealed and in place

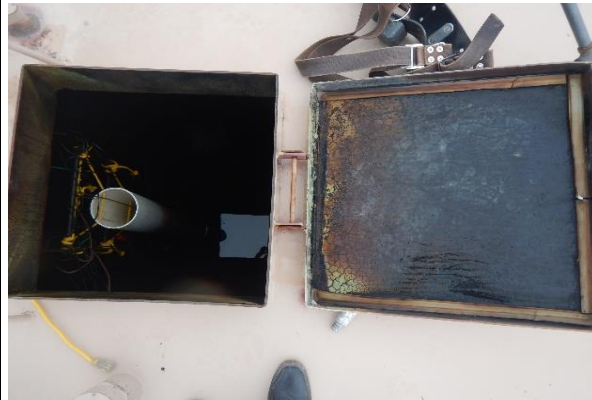
Conclusion/Discrepancies Three sides have gasket in place, minor corrosion on the underside of the lid

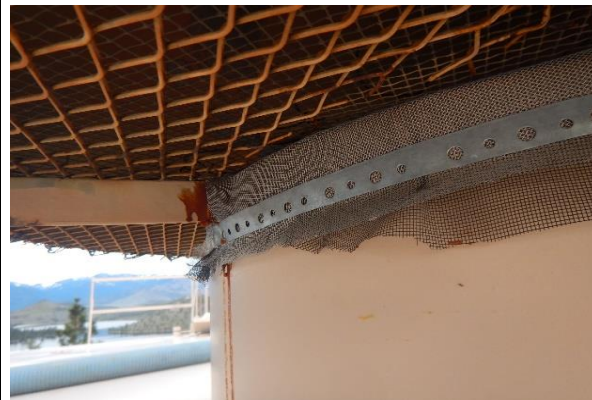
Conclusion/Discrepancies Vent is in good condition with proper 24 gauge screen in place minor rust staining from the humidity escaping from the vent

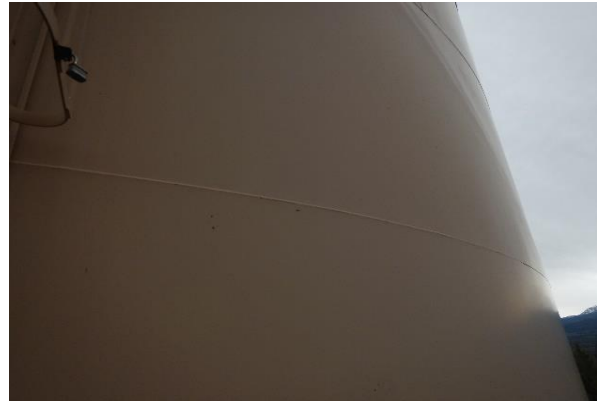
Conclusion/Discrepancies Minor nicks and scratches, no coating adhesion problems shell is in satisfactory condition

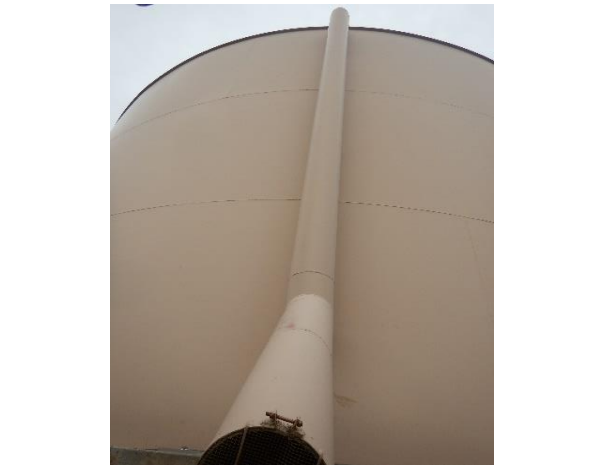
Conclusion/Discrepancies Coating on pipe is thin primer peaking through, overall satisfactory

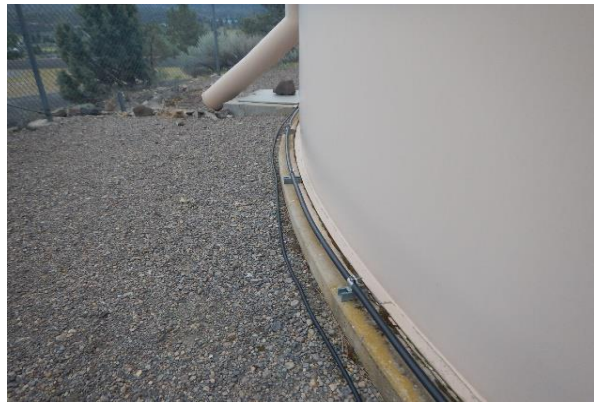
| Conclusion/Discrepancies Minor superficial cracking noted commonly found no concerns | | | | |

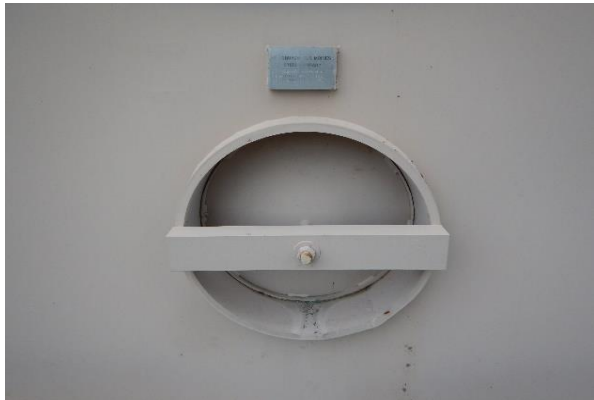
MANUAL LEVEL INDICATOR

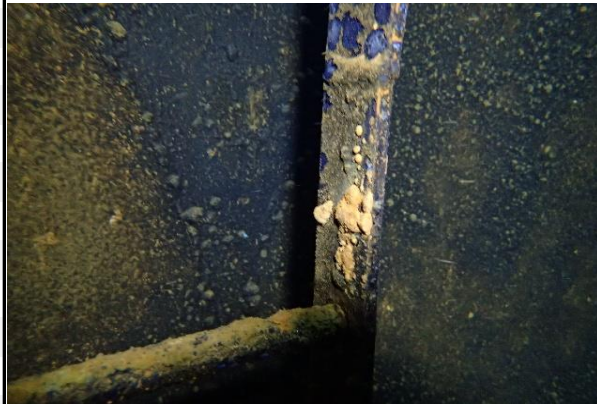
| Conclusion/Discrepancies: Coating is failing severe blistering with minor corrosion noted. | | | | |

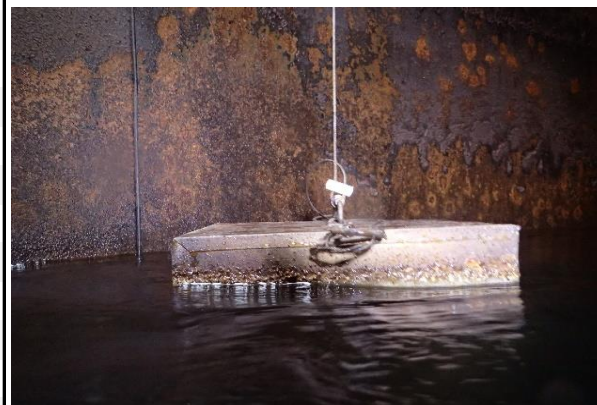
| Conclusion/Discrepancies: Float and hardware were found to be in satisfactory condition | | | | |
