## Lake Shastina Community Services District Field Report

Underwater Cleaning & Inspection  
300,000 Gallon  
Tank 3  
Potable Water Storage Tank

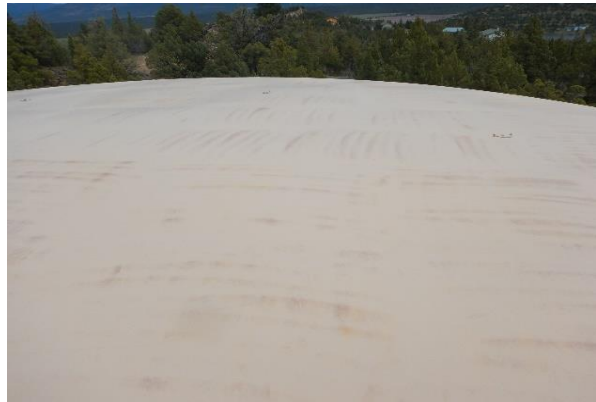
Safety Rail	None			
Satisfactory	<input type="checkbox"/>	N	<input type="checkbox"/>	
Coating				
Welds				
Corrosion	Y	<input type="checkbox"/>	N	<input type="checkbox"/>
Coating				
Satisfactory	Fair	<input checked="" type="checkbox"/>	N	<input type="checkbox"/>
Oxidized	Y	<input checked="" type="checkbox"/>	N	<input type="checkbox"/>
Pitting	Y	<input type="checkbox"/>	N	<input checked="" type="checkbox"/>
Delamination	Y	<input type="checkbox"/>	N	<input checked="" type="checkbox"/>
Corrosion	<2%	Y	<input checked="" type="checkbox"/>	N
Seams/Welds	Good			
Low Spots	Y	<input type="checkbox"/>	N	<input checked="" type="checkbox"/>
Cathodic Protection Plates	Good			
Conclusion/Discrepancies:	The coating is oxidized and thin, the primer is exposed with indications of corrosion starting to form.			
Plan for a new coating in the near future

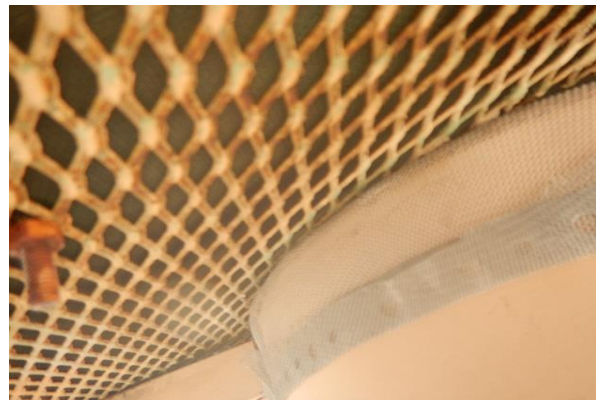
Satisfactory	Y	<input checked="" type="checkbox"/>	N	<input type="checkbox"/>
Coating				
Corrosion	% Y	<input type="checkbox"/>	N	<input checked="" type="checkbox"/>
Proper Design	Y	<input checked="" type="checkbox"/>	N	<input type="checkbox"/>
Screens	Y	<input checked="" type="checkbox"/>	N	<input type="checkbox"/>
Sealed Edges & Seams	Y	<input checked="" type="checkbox"/>	N	<input type="checkbox"/>
Cap/Cover	Y	<input checked="" type="checkbox"/>	N	<input type="checkbox"/>
Conclusion/Discrepancies	Screen in place and well secured Vent is in good condition no problematic concerns

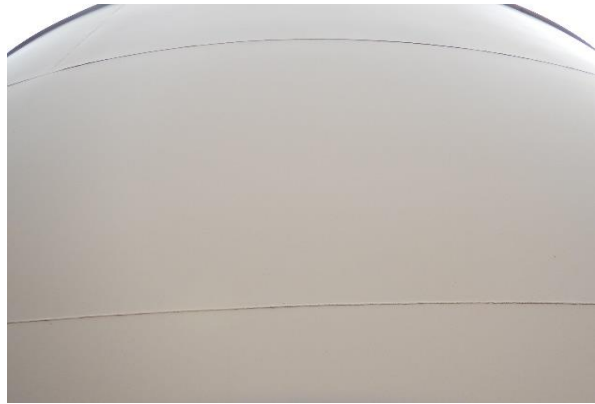
Conclusion/Discrepancies      Coating is oxidized but holding up well  
no discrepancies noted

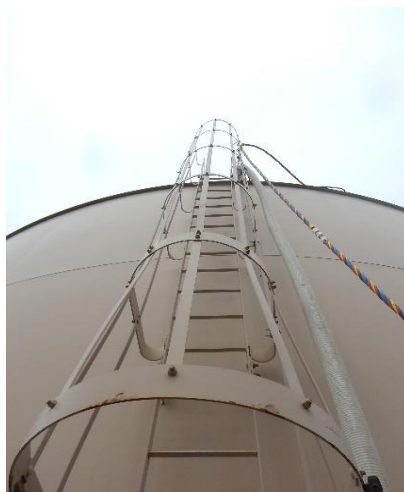
## OVERFLOW STRUCTURE

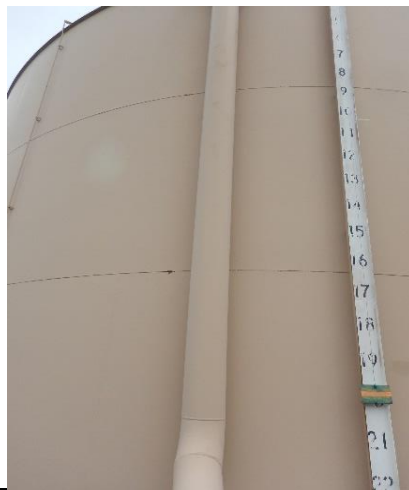
Attachments      In ground  
Foundation      Good  
Conclusion/Discrepancies      Pipe and braces are in  
good condition.

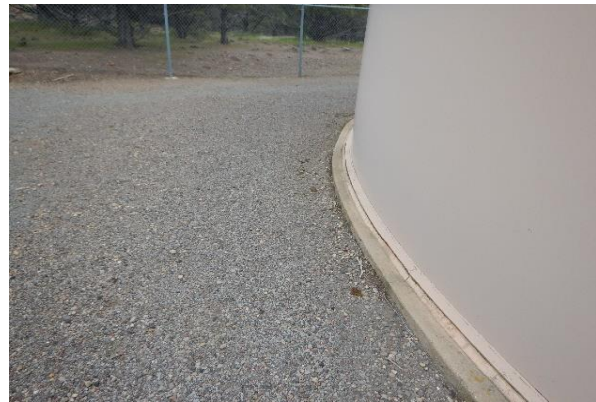
**Conclusion/Discrepancies** Concrete support ring has minor superficial cracking. No undermining or erosion noted overall satisfactory

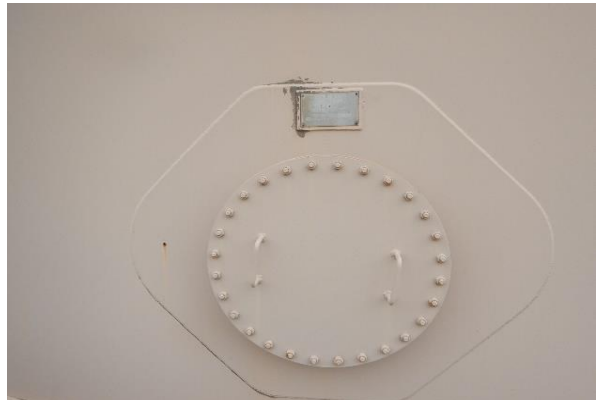
## MANUAL LEVEL INDICATOR

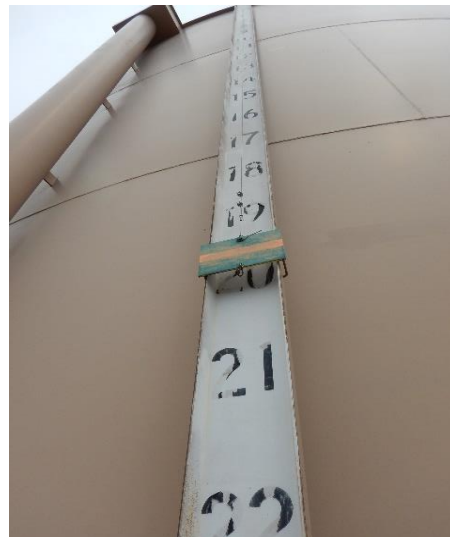
**Conclusion/Discrepancies:** Indicator appears to be in good condition

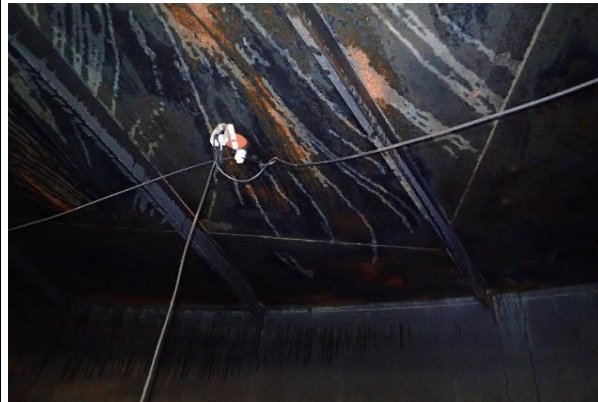
Conclusion/Discrepancies: Surface corrosion covers the plates, minor corrosion on the trusses and hardware. Coating is at the end of its service life and needs redone

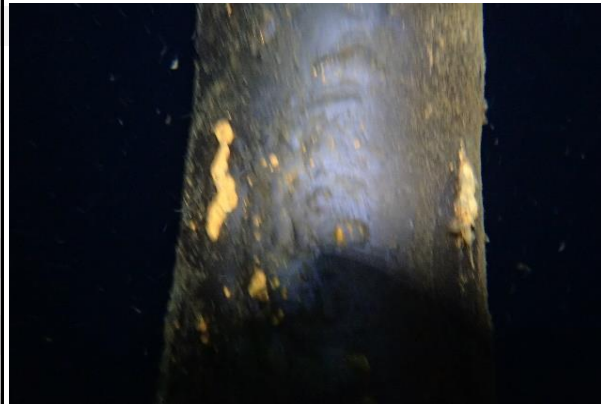
Coating				
Satisfactory	Y	<input type="checkbox"/>	N	<input checked="" type="checkbox"/>
Blistering	Y	<input checked="" type="checkbox"/>	N	<input type="checkbox"/>
Cracking	Y	<input checked="" type="checkbox"/>	N	<input type="checkbox"/>
Peeling	Y	<input type="checkbox"/>	N	<input checked="" type="checkbox"/>
Holidays	Y	<input type="checkbox"/>	N	<input checked="" type="checkbox"/>
Pitting	Y	<input type="checkbox"/>	N	<input checked="" type="checkbox"/>
Corrosion	10%	Y	<input checked="" type="checkbox"/>	N
Seams/Welds	Fair			
Floor/Base Plates	Fair			
Construction	Coated steel			
Conclusion/Discrepancies:	Blistering and surface corrosion noted from exposed steel. Coating has failed sandblast and recoat

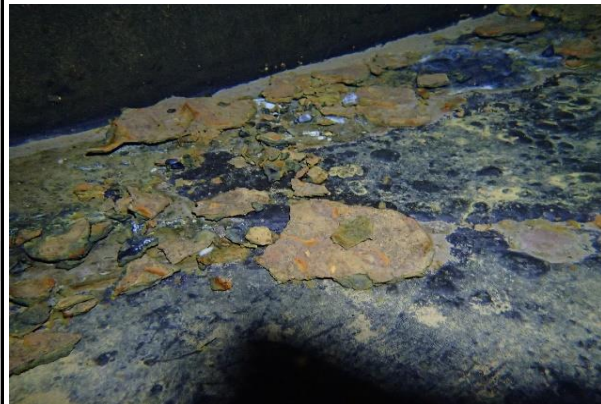
Coating				
Satisfactory	Y	<input type="checkbox"/>	N	<input checked="" type="checkbox"/>
Blistering	Y	<input checked="" type="checkbox"/>	N	<input type="checkbox"/>
Cracking	Y	<input checked="" type="checkbox"/>	N	<input type="checkbox"/>
Peeling	Y	<input checked="" type="checkbox"/>	N	<input type="checkbox"/>
Holidays	Y	<input type="checkbox"/>	N	<input checked="" type="checkbox"/>
Pitting	Y	<input type="checkbox"/>	N	<input checked="" type="checkbox"/>
Corrosion	10%	Y	<input checked="" type="checkbox"/>	N
Seams/Welds	Fair			
Conclusion/Discrepancies:	Coating is at the end of its service life with mineral build up and corrosion noted, recoat in the near future			
Sediment Depth	1/4 of an inch

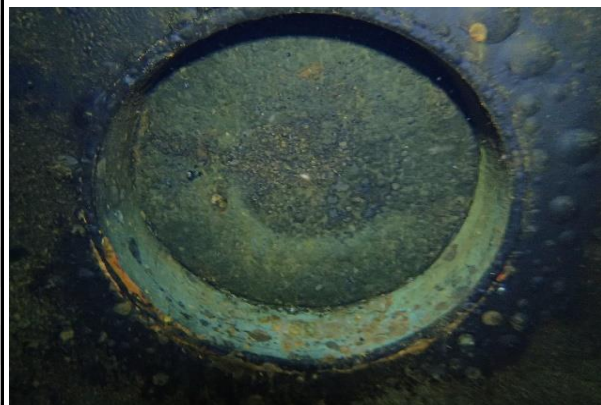
Coating				
Satisfactory	Y	<input type="checkbox"/>	N	<input checked="" type="checkbox"/>
Blistering	Y	<input checked="" type="checkbox"/>	N	<input type="checkbox"/>
Cracking	Y	<input type="checkbox"/>	N	<input checked="" type="checkbox"/>
Peeling	Y	<input type="checkbox"/>	N	<input checked="" type="checkbox"/>
Holidays	Y	<input type="checkbox"/>	N	<input checked="" type="checkbox"/>
Pitting	Y	<input type="checkbox"/>	N	<input checked="" type="checkbox"/>
Corrosion	5%	Y	<input checked="" type="checkbox"/>	N
Seams/Welds	Fair			
Conclusion/Discrepancies:	Blistering and surface corrosion noted around the outer edges and interior of the doorway extension

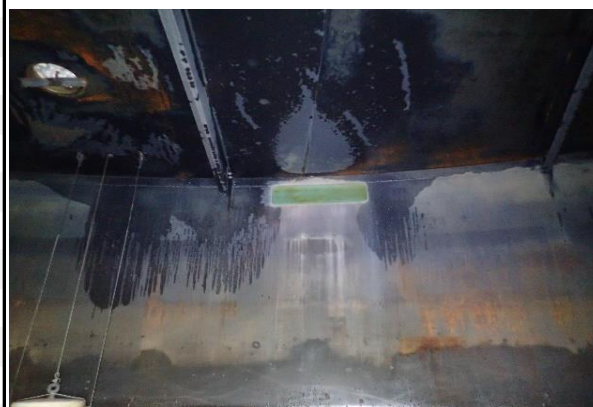
## MANUAL LEVEL INDICATOR

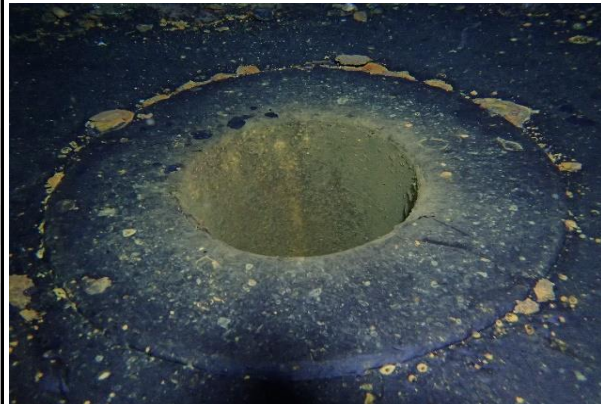
noted around the weld seam, minor corrosion on the interior of the e pipe

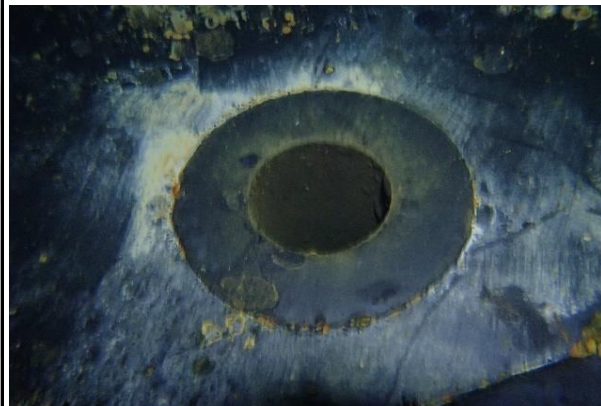
noted around the weld seam

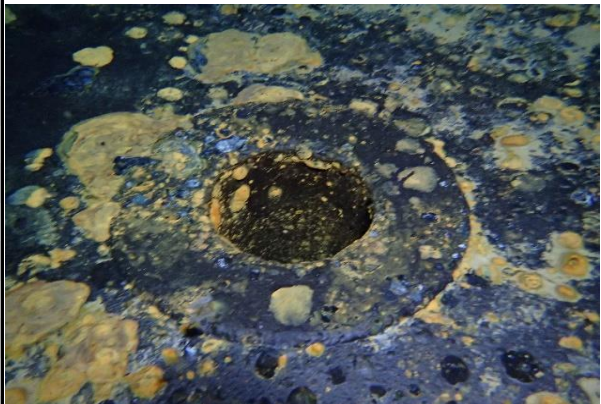
interior of the pipe and the weld seam coating in poor condition
